# espc::home report

# Single Survey

<b>Property address</b>	3F1, 9 Sloan Street, Leith, Edinburgh, EH6 8PL
-------------------------	--

<b>Prepared by</b>	Graham + Sibbald
--------------------	------------------

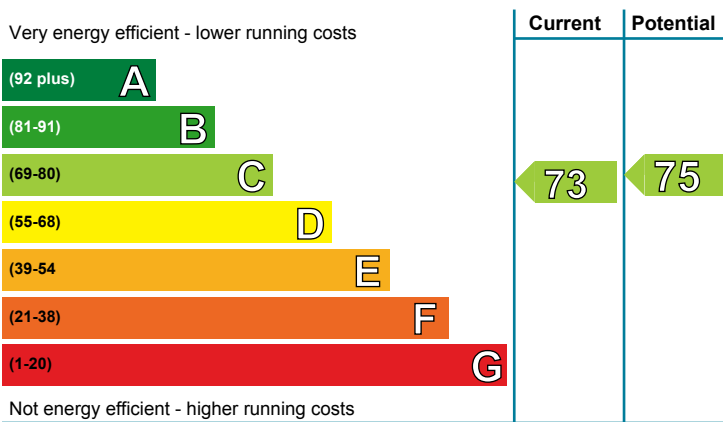
## Energy Efficiency Rating

This graph shows the current efficiency of your home, taking into account both energy efficiency and fuel costs. The higher this rating, the lower your fuel bills are likely to be.

Your current rating is **band C (73)**. The average rating for EPCs in Scotland is **band D (61)**.

The potential rating shows the effect of undertaking all of the improvement measures listed within your recommendations report.

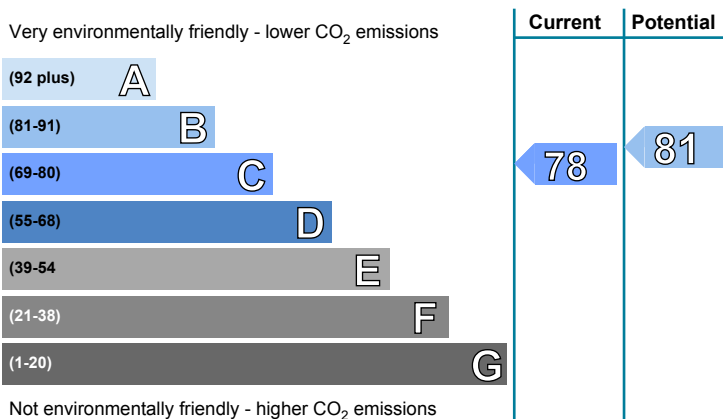
## Environmental Impact (CO<sub>2</sub>) Rating

This graph shows the effect of your home on the environment in terms of carbon dioxide (CO<sub>2</sub>) emissions. The higher the rating, the less impact it has on the environment.
